Docket No. 217 - Development and Management Plan Inspection

Northeast Utilities Service Company Certificate of Environmental Compatibility and Public Need for the construction of a 345-kV electric transmission line and reconstruction of an existing 115-kV electric transmission line between Connecticut Light and Power Company's Plumtree Substation in Bethel, through the towns of Redding, Weston, and Wilton, and to the Norwalk Substation in Norwalk, Connecticut.

Date: June 7, 2006

Location: 345kV Underground Route

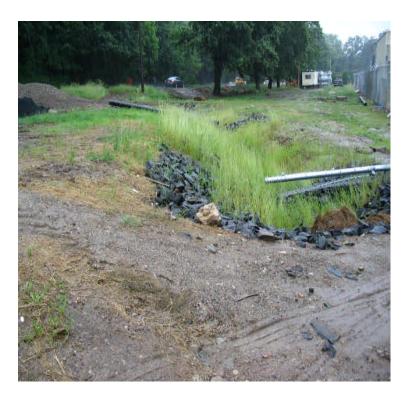
345kV (Norwalk Junction and Rt 7) Photo on the left shows some of the leftover stockpiles from work near the NJ access drive. Place controls here due to the proximity of the swale. Photo on the right shows the work near Old Danbury Rd with appropriate controls in place. 6/7/06

- Active work continues adjacent to the access drive of Norwalk Junction and	- See other sections for recommendations 6/7/06	- Needs attention.

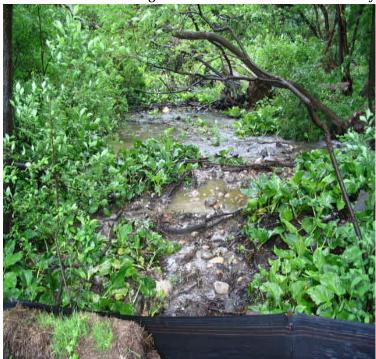
(HDD): Photo on the left shows the channel area beyond basin at the HDD. Due to the rain, there may be more sediment buildup that has to be removed. Photo on the right shows the basin with old haybales in place. 6/7/06

- Even though effort was made to remove sediment from beyond the basin, the washouts to the east, reintroduced silt in some of the channels. 5/25-6/7/06	- Make additional efforts to remove sediment here in the channels due to the new accumulation 5/25-6/7/06	- Needs attention

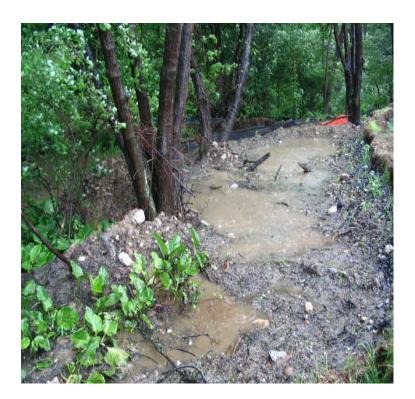
Photo on the left shows the area along the east of the basin that will be lightly graded and allowed to revegetate with wetland species. Photo on the right shows where haybales were placed in an attempt to filter some of the run-off. This area will be restored soon. 6/7/06

- Wetlands directly to the east of the basin continue to have worsening sediment accumulation over 6" that will require removal. 1/19-6/7/06	- Sediment buildup should be removed carefully by hand to the extent feasible. 3/9-6/7/06 This should be done in the near future. 6/7/06	-Still needs attention ASAP
	-The soil surface of the HDD yard is still highly disturbed and some areas of wetland are within the silt fence work limits. 4/12-6/7/06 -New erosion controls will also be installed at the edge of the proposed parking area. 6/7/06	- Restoration will consist of grading the basin, installing topsoil and hyroseeding. Portions along the perimeter will be returned to wetland vegetation while the remainder will be used for school parking. 5/31-6/7/06	-Restoration will be occurring within the next week

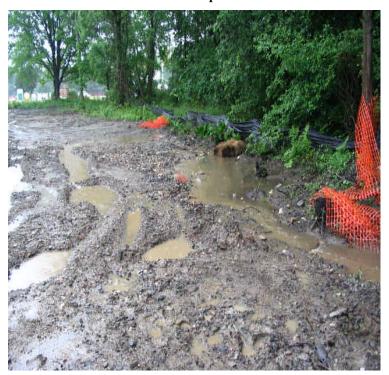
Photo on the left shows the area where the run-off is channeling and entering the wetland area. This area will also be restored. (Rt 7- Allen's Meadow Park) Photo on the right shows the area north of the Wilton High School J&B that still needs restoration. 6/7/06

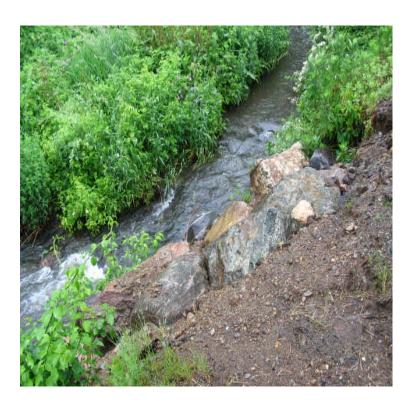
(Georgetown Deli) Photo on the left shows where the boulders were installed in the bank in an attempt to stabilize. Photo on the right shows where the erosion control blanket was completely installed along the bank that had been eroding. 6/7/06

- The stream slope to the north of the Deli has the boulders installed for stabilization. 6/7/06	- Continue to monitor. 6/7/06	- EC mats and boulders were in place

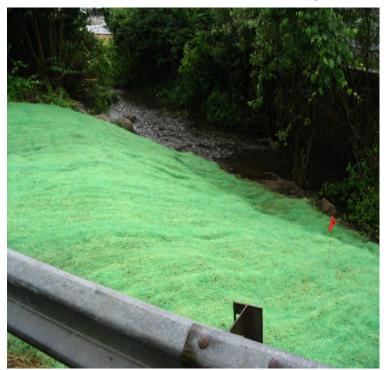
Photo on the left shows the new erosion control mat installed along the J&B slope. This also covers the area of bank that slumped at the stream edge. Photo on the right shows the bank to the south of the stream that has additional mulch and seed. 6/7/06
